QUEENSLAND P76
OWNERS CLUB
INCORPORATED

COMPONENT FAILURE - HUB ASSEMBLY
TORSIONAL VIBRATION CRANKSHAFT
PULLEY (V8)

RE: LEYLAND P76 TORSIONAL VIBRATION DAMPER - HUB ASSEMBLY

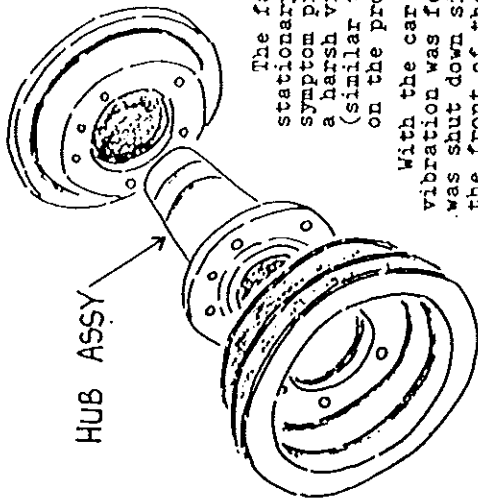
HUB ASSY

A recent reported instance of the failure of the Hub Assy of the Crankshaft Pulley is brought to the attention of all members.

The failure occurred whilst the car was stationary, with the engine idling. The only symptom prior to the hub disintegration was a harsh vibration felt through the drive train (similar to a badly worn front universal joint on the propeller shaft).

With the car stopped, bonnet up, increased vibration was felt from the engine, and the motor was shut down simultaneous with a loud bang from the front of the car. Inspection revealed the crankshaft pulley and damaged hub lying on the ground. Damage to other components was confined to a mangled water pump pulley, a cracked radiator fan shroud, and a broken alternator drive belt. No doubt damage could have been a lot more severe had the failure occurred with the vehicle at speed and the engine under load.

Closer inspection revealed no damage to the crankshaft, oil seal, or other components in the immediate vicinity. The car was repaired by the fitting of another hub assembly and water pump pulley. During removal of original bolt, an incorrect washer was noticed. Instead of this being a thick flat type, a wheel bearing keyed washer had been used. Although not responsible for this failure, the incorrect washer was discarded, and the correct type was installed on reassembly.

Although this type of failure is thought to be a rare occurrence, the increasing age of the vehicles and components may require closer inspection during servicing.

The hub assembly should be checked thoroughly for cracks, etc, whenever driveline or engine vibration causes concern, even if this means removing the pulley and hub assembly from the vehicle for proper inspection.

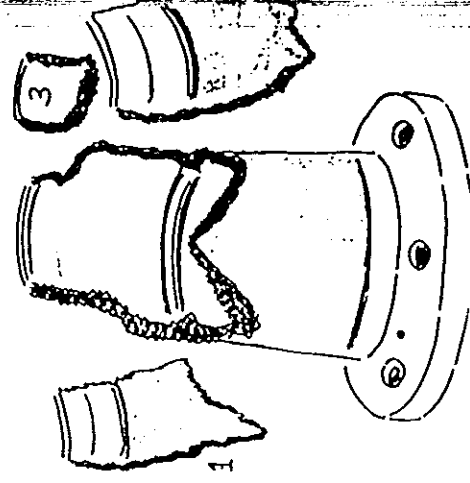
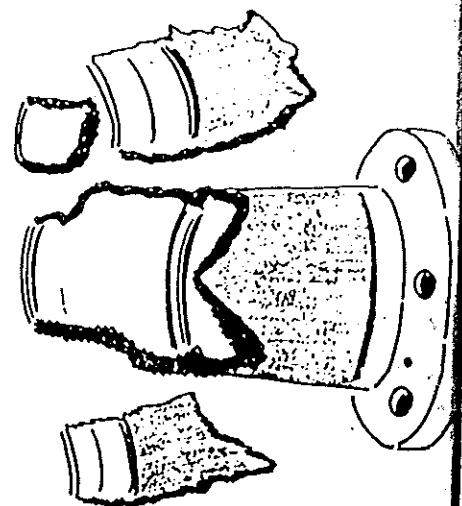
The Technical Notice on the preceding page appeared in the May '91 issue of Westwards. Since then, there have been several other similar reported failures of the hub assembly. In one case, in rural WA, the component disintegrated whilst the car was travelling under load, causing extensive damage to the V8 engine (write off), and to other parts in the engine bay.

The Club has had an expert examine the component originally reported in May '91, and his report appears on the following two pages. For reference, the numbers on the diagram at right are the pieces mentioned in the report.

The nature of the Report confirms that the failure was due to the age of the part, plus the mileage. The failure was not due to faults in manufacture. Cars with double or triple pulleys (e.g. air conditioning, power steering) would seem to be at greater risk of this component failure.

It is our considered opinion that failure of this component was the result of repeated torque application and shock load, during normal use, creating a fatigue fracture which progressed to the point where it allowed the component metallurgy to flex in a manner for which it was not designed. This abnormal flexing caused the subsequent fractures resulting in immediate failure.

This fracture site was of a long term nature and was considered to have occurred as a result of progressive fatigue rather than metallurgical fault.

This failure site is considered to have been the primary cause of eventual component failure.

All members are again reminded of the IMPORTANCE of thoroughly inspecting the crankshaft pulley hub assembly on their cars during periodic maintenance. This may necessitate the removal of the hub assembly for proper inspection. This task should definitely NOT BE OVERLOOKED whenever engine rebuilding, etc is undertaken.

Fennac Automotives have organized a local manufacture of a replacement item. This new hub assembly is of SG cast iron (stronger than steel), whereas the original assembly was of black cast iron. Approximate cost of this new hub assembly is around \$130, and would be an extremely wise inclusion in any planned major engine work being done by members. The cost is dependant on the number of assemblies manufactured (i.e. the more made - the cheaper the item).
